Manhole Inspection Summary

Manhole # S41A2_014MH

Insp Date: **4/22/08 12:53 PM**

Location Address: **3703 8th St.**

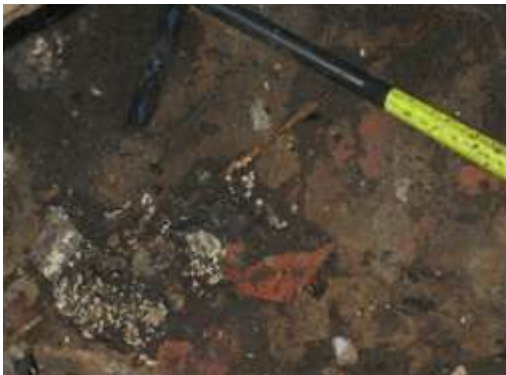
Defect 2

Condition: ☐ Sound ☐ Cracked ☐ Root Intrusion ☐ Deteriorated ☐ Leaks ☒ **Debris**

debris

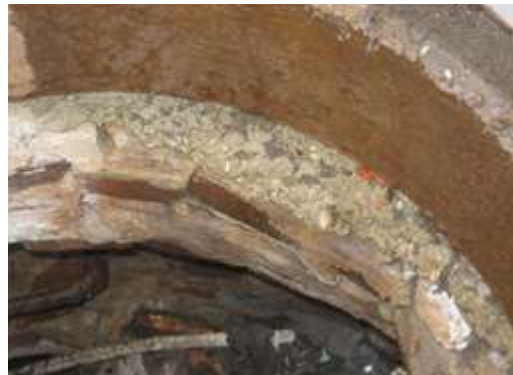
Defect 1

Condition: ☐ Sound ☒ **Cracked** ☐ Root Intrusion ☒ **Loose Brick** ☒ **Deteriorated**

Infiltration: ☐ None ☒ **Joint** ☐ Cracks ☐ Mortar ☐ Roots ☐ Wall

loose bricks on chimney

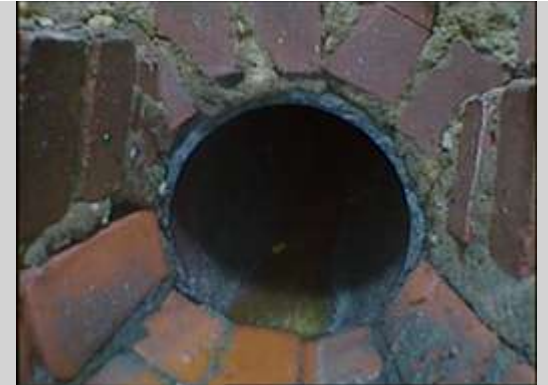
12 O'Clock Outflow

8 in. Circular Gravity Sewer
Pipe Out @ 12 O'Clock

Infiltration: **None** Pipe Seal Cond: **Sound**

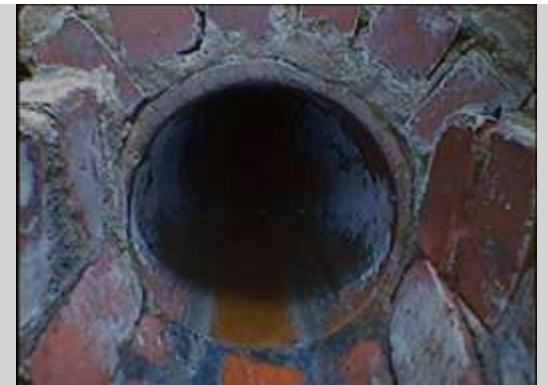
3 O'Clock Inflow

8 in. Circular Service Sewer
Pipe In @ 3 O'Clock

Infiltration: **None** Pipe Seal Cond: **Sound**

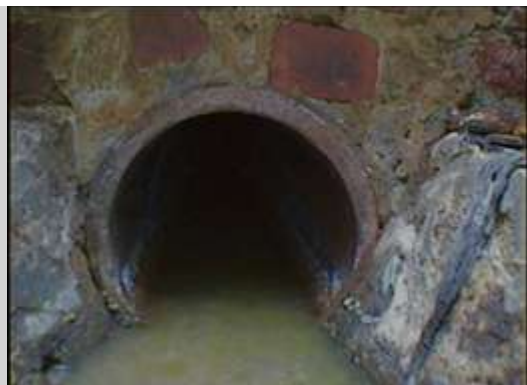
6 O'Clock Inflow

8 in. Circular Gravity Sewer

Infiltration: **None** Pipe Seal Cond: **Sound**
